**REPORT NUMBER: NCAP-CAL-18-002**

**NEW CAR ASSESSMENT PROGRAM (NCAP)  
FRONTAL BARRIER IMPACT TEST**

**General Motors LLC  
2018 Chevrolet Traverse  
Four Door SUV**

**NHTSA No: M20180107**

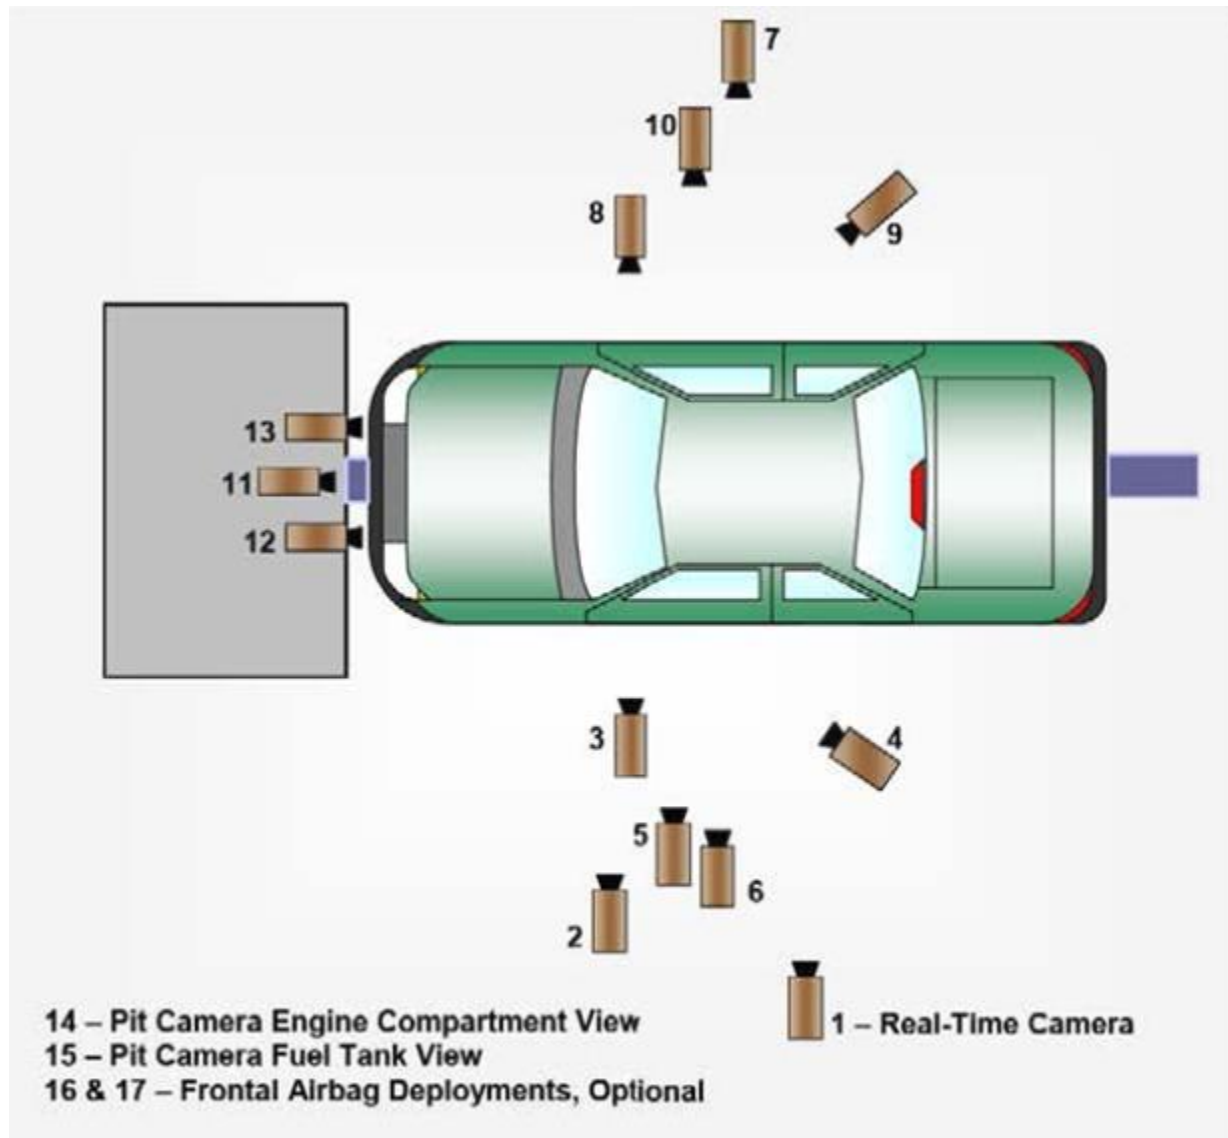
**CAMERA POSITIONS FOR FRONTAL IMPACTS**

Top View

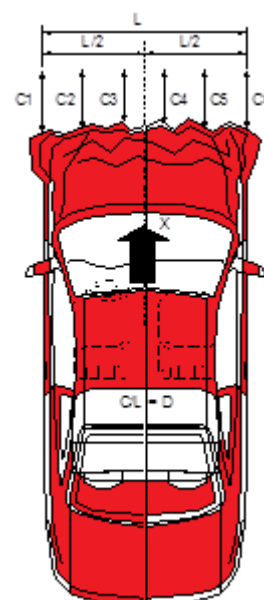
**CRUSH PROFILE**

Collision Deformation Classification: 12FDEW3  
Midpoint of Damage: C4  
Damage Region Length (mm): 1482  
Impact Mode: Frontal

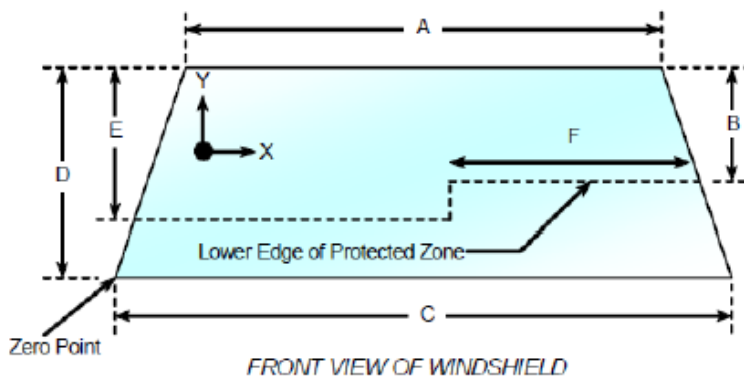
**WINDSHIELD PERIPHERY MEASUREMENTS**

Measurement	Pre-Test (mm)	Post-Test (mm)	% Retention
Left Side	2370	2370	100
Right Side	2370	2370	100
Total	4740	4740	100

Item	Units	Value
A	mm	1368
B	mm	518
C	mm	1582
D	mm	895
E	mm	493
F	mm	528

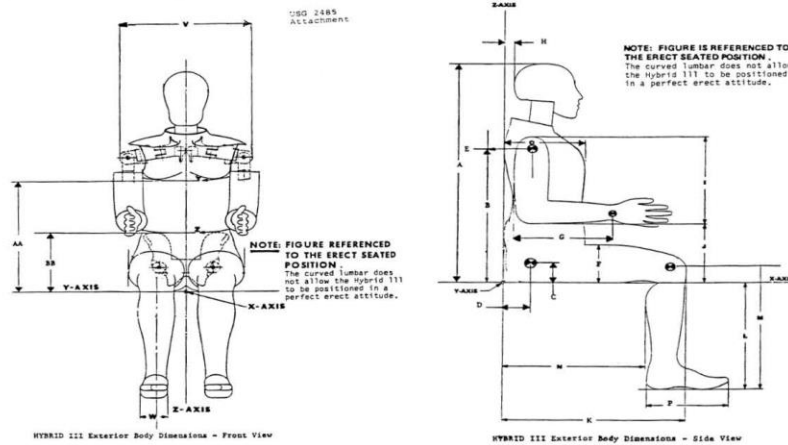
Symbol	Description	Specification (in)		Result (in)	Pass/Fail
A	Sitting Height	34.6	35.0	34.8	Pass
B	Shoulder Pivot Height	19.9	20.5	20.0	Pass
C	H-Point Height	3.3	3.5	3.5	Pass
D	H-Point from Backline	5.3	5.5	5.4	Pass
E	Shoulder Pivot from Backline	3.3	3.7	3.5	Pass
F	Thigh Clearance	5.5	6.1	6.0	Pass
G	Back of Elbow to Wrist Pivot	11.4	12.0	11.5	Pass
H	Head Back to Backline	1.6	1.8	1.7	Pass
I	Shoulder to Elbow Length	13.0	13.6	13.2	Pass
J	Elbow Rest Height	7.5	8.3	8.2	Pass
K	Buttock to Knee Length	22.8	23.8	23.1	Pass
L	Popliteal Height	16.9	17.9	17.8	Pass
M	Knee Pivot Height	19.1	19.7	19.6	Pass
N	Buttock Popliteal Length	17.8	18.8	18.3	Pass
O	Chest Depth without Jacket	8.4	9.0	8.5	Pass
P	Foot Length (right)	9.9	10.5	10.3	Pass
V	Shoulder Breadth	16.3	17.2	17.0	Pass
W	Foot Breadth	3.6	4.2	4.0	Pass
Y	Chest Circumference with Jacket	38.2	39.4	39.3	Pass
Z	Waist Circumference	32.9	34.1	34.0	Pass
AA	Reference Location (Chest Circumference)	16.9	17.1	17.0	Pass

BB	Reference Location (Waist Circumference)	8.9	9.1	9.0	Pass

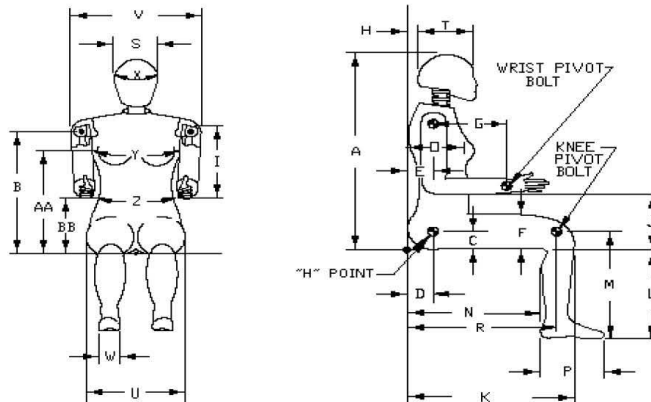
Symbol	Description	Specification (mm)		Result (mm)	Pass/Fail
A	Sitting Height	775	800	782	Pass
B	Shoulder Pivot Height	432	457	440	Pass
C	H-Point Height	81	86	84	Pass
D	H-Point from Backline	145	150	147	Pass
E	Shoulder Pivot from Backline	69	84	75	Pass
F	Thigh Clearance	119	135	126	Pass
G	Back of Elbow to Wrist Pivot	244	259	250	Pass
H	Head Back to Backline	43	48	45	Pass
I	Shoulder to Elbow Length	277	297	285	Pass
J	Elbow Rest Height	183	203	188	Pass
K	Buttock to Knee Length	521	546	541	Pass
L	Popliteal Height	356	376	366	Pass
M	Knee Pivot Height	394	419	401	Pass
N	Buttock Popliteal Length	414	439	430	Pass
O	Chest Depth without Jacket	175	191	180	Pass
P	Foot Length (right)	219	234	220	Pass
R	Buttock To Knee Pivot Length	457	483	462	Pass
S	Head Breadth	137	147	142	Pass
T	Head Depth	178	188	182	Pass
U	Hip Breadth	300	315	307	Pass
V	Shoulder Breadth	351	366	361	Pass
W	Foot Breadth	79	94	85	Pass
X	Head Circumference	528	549	537	Pass

Y	Chest Circumference with Jacket	851	881	855	Pass
Z	Waist Circumference	460	790	776	Pass
AA	Reference Location (Chest Circumference)	333	358	345	Pass
BB	Reference Location (Waist Circumference)	160	170	165	Pass
